NRL/MR/6170-04-8763

Replacement of Chromium Electroplating on C-2, E-2, P-3, and C-130 Propeller Hub Components Using HVOF Thermal Spray Coatings

March 31, 2004

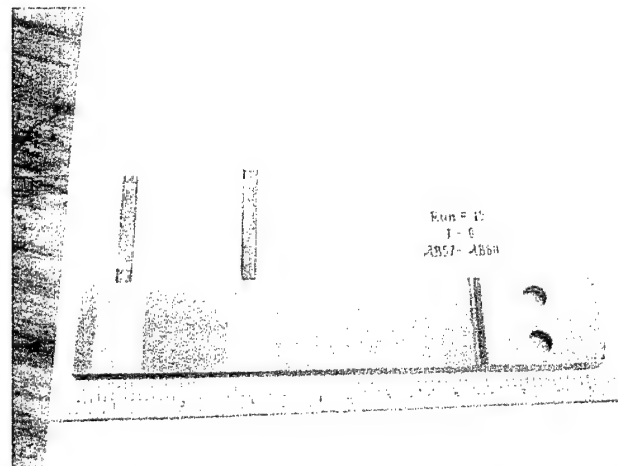
Figure 3-31. T-800 Reciprocating Against Copper Counter-Faces
